TECHNICAL BULLETIN

SUBJECT: CAR DOOR REVERSING DEVICE

EQUIPMENT: PEELLE CAR DOORS WITH LIGHT CURTAIN REVERSING DEVICE
(PEELLE PART NUMBERS 4690 AND 4691)

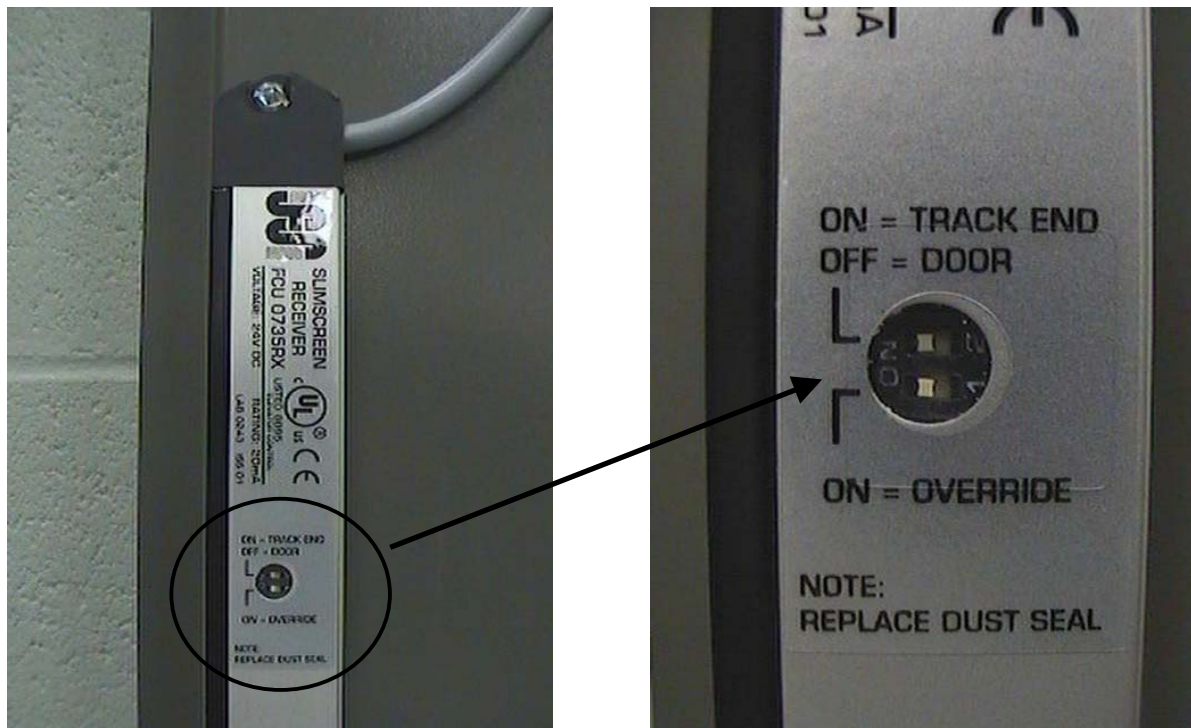
DESCRIPTION: PEELLE HAS DISCOVERED THAT A NUMBER OF LIGHT CURTAINS WERE SENT OUT INCORRECTLY ADJUSTED. THE INCORRECT ADJUSTMENT IS IN THE FORM OF DIP SWITCH PLACEMENT IN THE RECEIVER. THE INCORRECT DIP SWITCH PLACEMENT REDUCES THE SENSITIVITY OF THE SYSTEM AND WILL REQUIRE ADJUSTMENT TO FUNCTION AT OPTIMAL SENSING RANGE (SEE BELOW).

ACTION: ENSURE BOTH DIP SWITCHES ARE SET TO THE “ON” POSITION (PUSHED TO THE LEFT). THE DIP SWITCHES CAN BE FOUND AT THE TOP OF THE LIGHT CURTAIN RECEIVER ON THE LEFT HAND CAR DOOR RAIL (VIEWED FROM INSIDE THE CAR LOOKING OUT).
