TECHNICAL BULLETIN

PREVENTATIVE MAINTENANCE - ACTION RECOMMENDED

SUBJECT: PNP ADAPTER FOR LIGHT CURTAIN RECEIVER.

EQUIPMENT: PEELLE CAR DOOR LIGHT CURTAIN REVERSING DEVICE (PEELLE PART

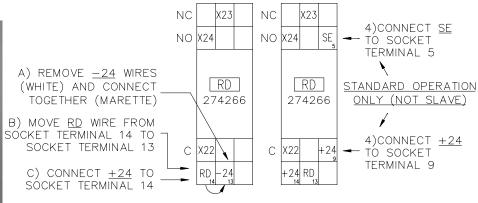
RD RELAY EXISTING WIRING RD RELAY NEW WIRING

DESCRIPTION: PEELLE HAS DISCOVERED THAT THE PNP ADAPTER (46903) THAT WAS

BEING SHIPPED WITH THE PEELLE CAR DOOR LIGHT CURTAIN HAS POTENTIAL TO FAIL IF WIRED INCORRECTLY. THE PNP ADAPTER CHANGES THE OUTPUT OF THE LIGHT CURTAIN RECEIVER FROM NPN (-24VDC) TO PNP (+24VDC). THROUGH MINOR WIRING MODIFICATIONS THE PNP ADAPTER

3) REWIRE THE RD RELAY INSIDE THE DOOR CONTROLLER:

A) REMOVE THE <u>-24</u> WIRES FROM SOCKET TERMINAL 13 AND CONNECT TOGETHER (MARETTE).

B) REMOVE <u>RD</u> WIRE FROM SOCKET TERMINAL 14 AND CONNECT TO SOCKET TERMINAL 13.

C) ADD WIRE FROM TERMINAL <u>+24</u> TO SOCKET TERMINAL 14.
