TECHNICAL BULLETIN

CODE INCOMPLIANCE – PREVENTATIVE ACTION REQUIRED

SUBJECT: HOISTWAY LANDING DOOR UNLOCKING DEVICE (2374 SERIES)

EQUIPMENT: PEELLE PART NUMBERS 2374, 2374N1 & 2374N4

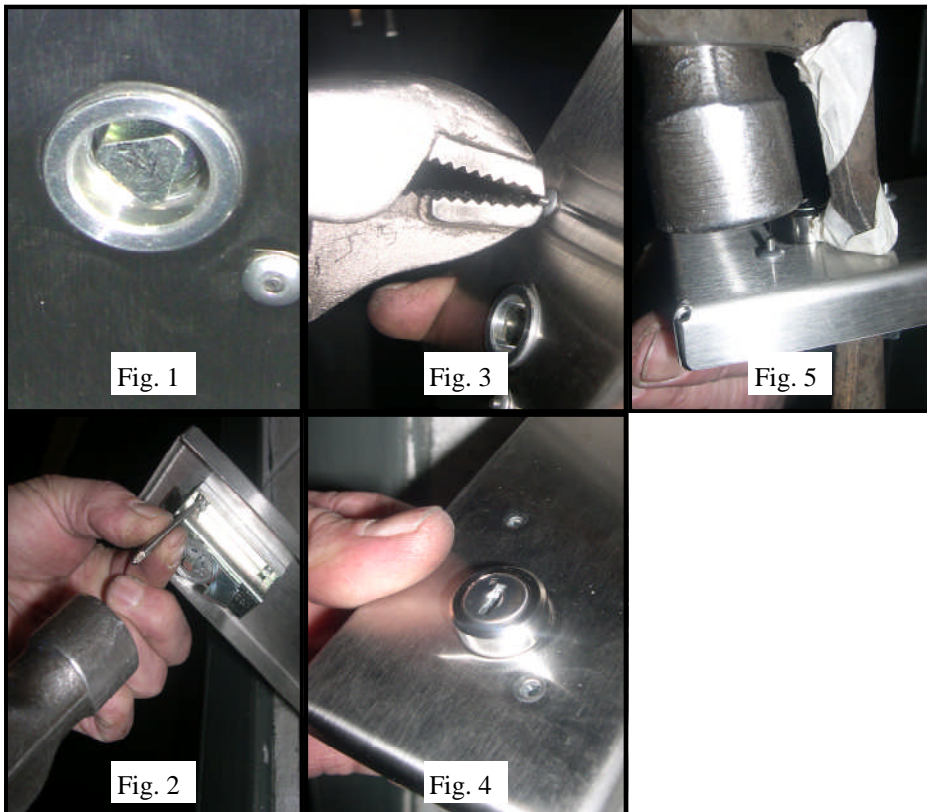
DESCRIPTION: PEELLE HAS DISCOVERED A CODE COMPLIANCY ISSUE WITH OUR STANDARD UNLOCKING DEVICE. IT HAS BEEN DETERMINED THAT THE 2374 SERIES UNLOCKING DEVICES DO NOT COMPLY WITH SECTION 2.12.6.2.2 IN THE A17/B44 SAFETY CODE FOR ELEVATORS WHICH STATES *“THE DEVICE SHALL BE DESIGNED TO PREVENT UNLOCKING THE DOOR WITH COMMON TOOLS”*.

ACTION: PEELLE HAS RE-DESIGNED THE LATCH INSIDE THE 2374 SERIES UNLOCKING DEVICES TO COMPLY WITH THE ABOVE MENTIONED CODE REQUIREMENT. IF YOU CURRENTLY HAVE THE TRIANGLE ACTUATOR (FIG 1.), REPLACEMENT IS REQUIRED. TO REPLACE, LOOSEN THE TWO DRIVE RIVETS THAT ATTACH THE LATCH TO THE BOX COVER WITH A PUNCH OR SMALL DRILL BIT (FIG 2.). GRAB DRIVE RIVETS ON FACE SIDE OF COVER WITH PLIERS AND PULL TO REMOVE (FIG 3.). INSERT NEW LATCH INTO COVER (FIG 4.). HAMMER TWO NEW DRIVE RIVETS INTO PLACE TO SECURE NEW LATCH (FIG 5.).
