**The Peelle Company**

**TECHNICAL BULLETIN**  
**PREVENTATIVE MAINTENANCE REQUIRED**

**SUBJECT:** RETIRING CAM BOTTOM ASSEMBLY

**EQUIPMENT:** PEELLE 233010 RETIRING CAM BOTTOM ASSEMBLY

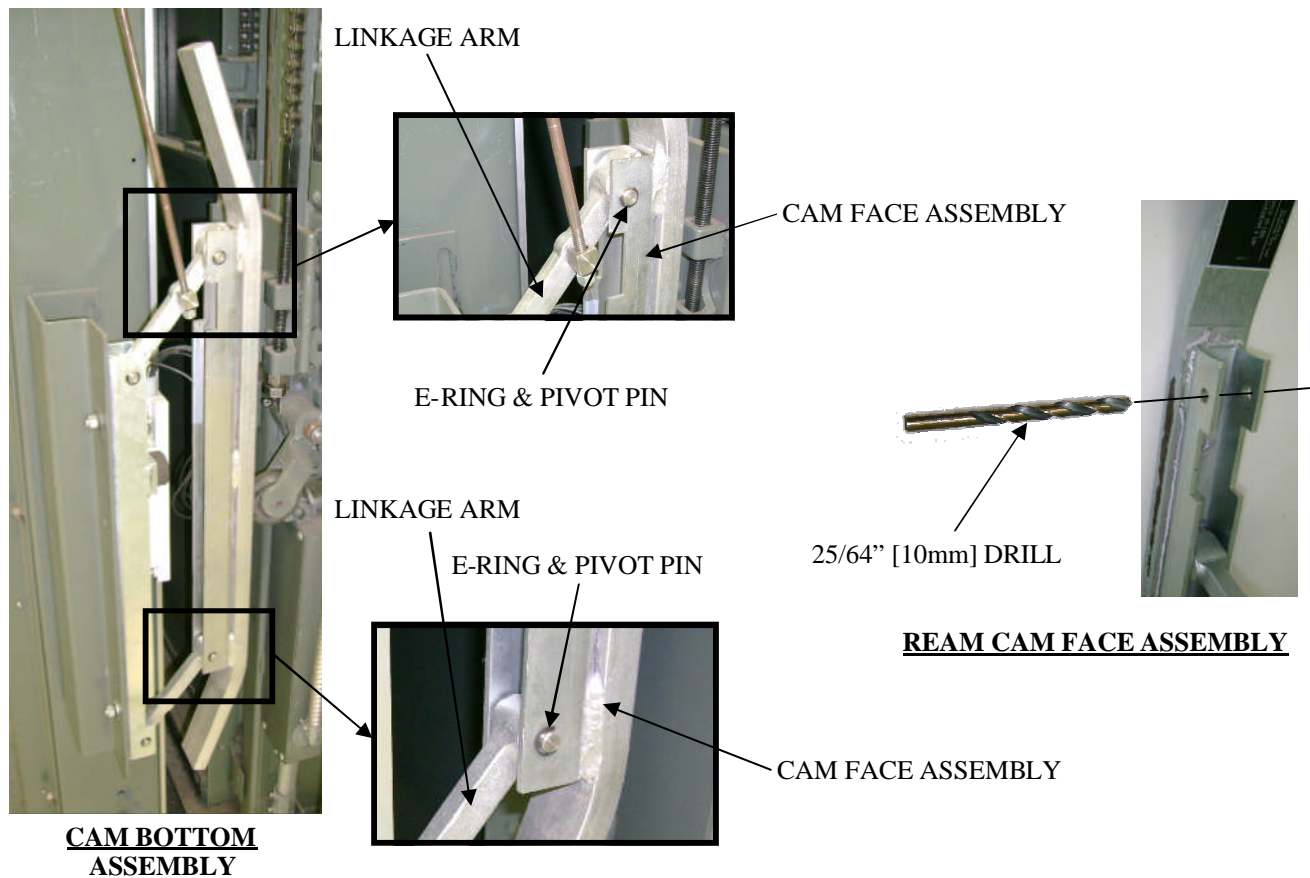
**DESCRIPTION:** PEELLE HAS DISCOVERED THAT SOME 233010 RETIRING CAM BOTTOM ASSEMBLIES ARE NOT FULLY EXTENDING OR RETIRING AS DESIGNED. THIS IS DUE TO THE HOLES ON THE CAM FACE ASSEMBLY BEING OUT OF ALIGNMENT WITH THE HOLES IN THE LINKAGE ARMS. THIS PROBLEM IS VISIBLE WHEN THE CAM FACE IS VERY SLOW MOVING OR STRUGGLES TO FINAL RETIRED/EXTENDED POSITION.

**ACTION:** REMOVE THE E-RINGS AND PIVOT PINS THAT CONNECT THE LINKAGE ARMS TO THE CAM FACE ASSEMBLY. USE A 25/64" [10mm] DRILL TO REAM THE CAM FACE ASSEMBLY.
