**The Peelle Company**

## TECHNICAL BULLETIN

Moisture Resistant Interlocks and Gate Contacts  
Explosion Resistant Interlocks and Gate Contacts

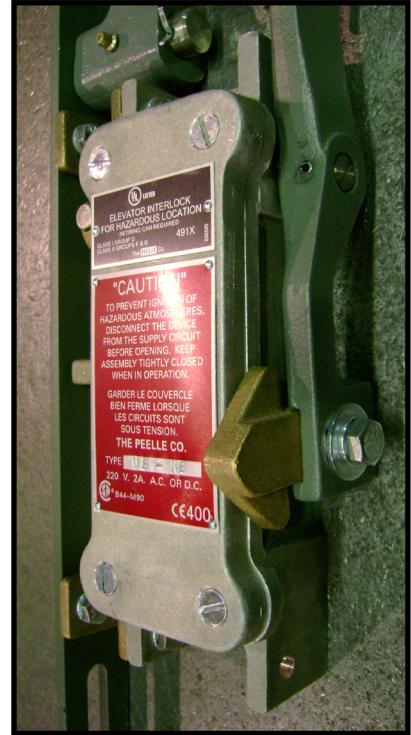
**CAST BOX**

Peelle has discovered a potential problem with the DC (door closed) contact in the lower box of the Nema 4/4X/7 interlock. If the retaining ring that secures the contact bar assembly to the contact stud is removed or fails, the contact bar assembly could wedge against the contact point assembly and provide a false DC (door closed) signal. The issue is similar in the gate contacts listed above except that the signal would be GC (gate closed).

**Explosion / Moisture**

Peelle has designed replacement parts. The new replacements allows the contact bar to fall off the contact stud should the retaining ring be removed or fail.

**Replacement Kit Number - 030015**

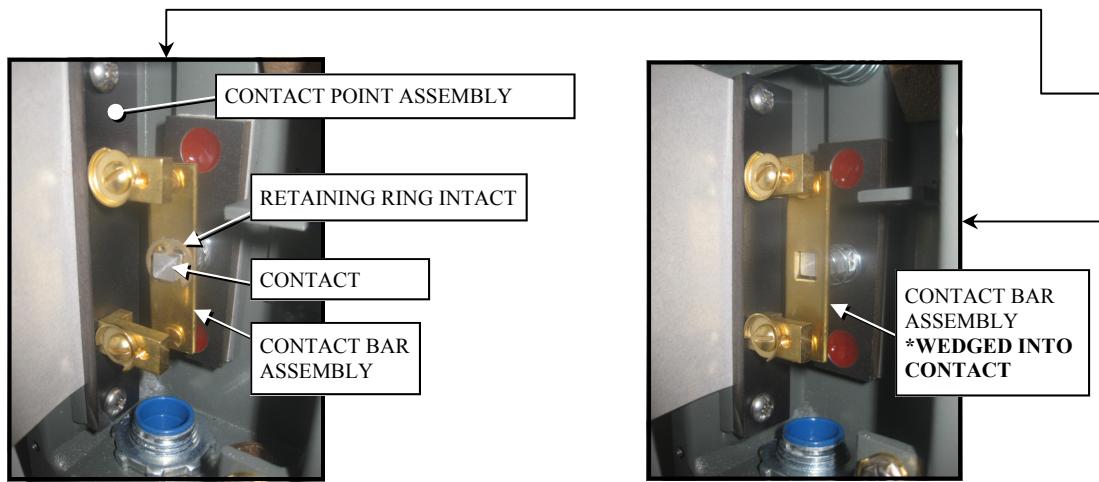
**RETAINING RING INTACT  
(NORMAL CONDITION)**

**RETAINING RING DISLODGED  
(PROBLEM CONDITION)**

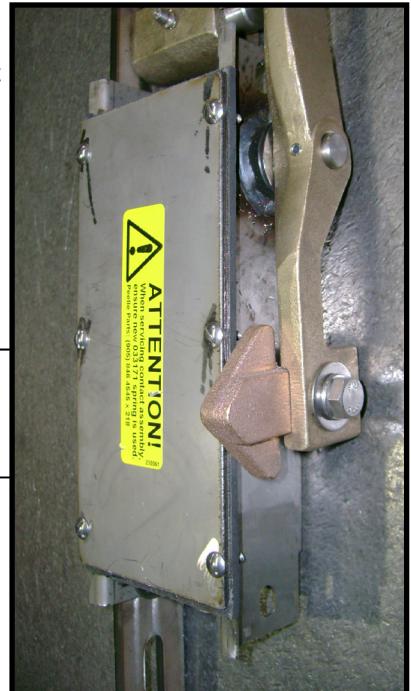
**FORMED BOX  
Moisture**

**Replacement Part Number - 035510**
