TECHNICAL BULLETIN

SUBJECT: PEELLE 250723 PINION GEAR

EQUIPMENT: PEELLE CAR DOOR OPERATORS (PART NUMBERS: 2518, 2517, 2548, 2547, 2528, 2527 AND 2549)

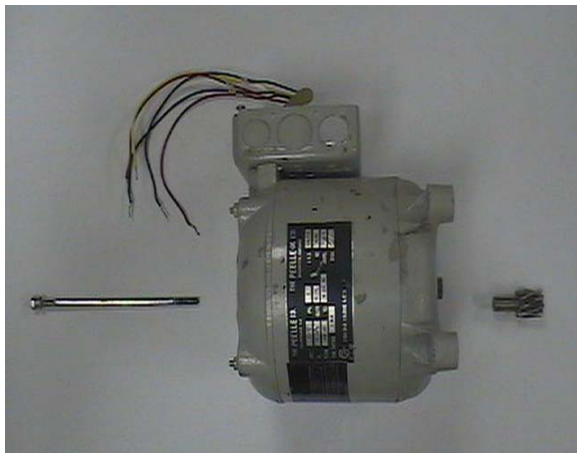
DISASSEMBLED MOTOR

1. TURN OFF POWER.
2. UNBOLT GATE MOTOR.
3. REMOVE CAP AT BACK OF MOTOR.
4. UNSCREW PINION BOLT EXCEPT FOR THREE THREADS.
5. HAMMER PINION BOLT HEAD TO LOOSEN PINION.
6. EXCHANGE PINION AND REASSEMBLE.

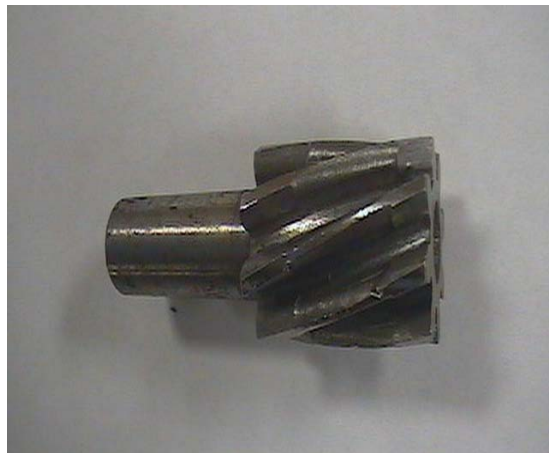
DESCRIPTION: PEELLE HAS DISCOVERED THAT THE MATERIAL USED FOR THE 250723 PINION GEAR ON THE ABOVE LIST OF CAR DOOR OPERATORS WAS NOT MANUFACTURED TO PEELLE'S HARDNESS SPECIFICATION. THIS COULD RESULT IN PREMATURE PINION WEAR. THIS APPLIES TO JOBS SHIPPED BETWEEN JANUARY 1ST 2002 AND OCTOBER 30TH 2002.

250723 PINION GEAR

ACTION: CONTACT PEELLE FOR A FREE REPLACEMENT 250723 PINION GEAR. FOR USA – CONTACT 1-800-645-1056 EXT. 11 LAURA NEUMANN. FOR CANADA AND INTERNATIONAL – CONTACT 905-846-4545 EXT. 220 LEN HOUWEN. TO REPLACE 250723 PINION GEAR:
